CHAMBER OF COMMERCE BUILDING *fka Bivins Building*

Building Location: 1000 South Polk Street Amarillo, Texas

Date of Site Visit: 9/21/06

Field Notes, Background & General Observations

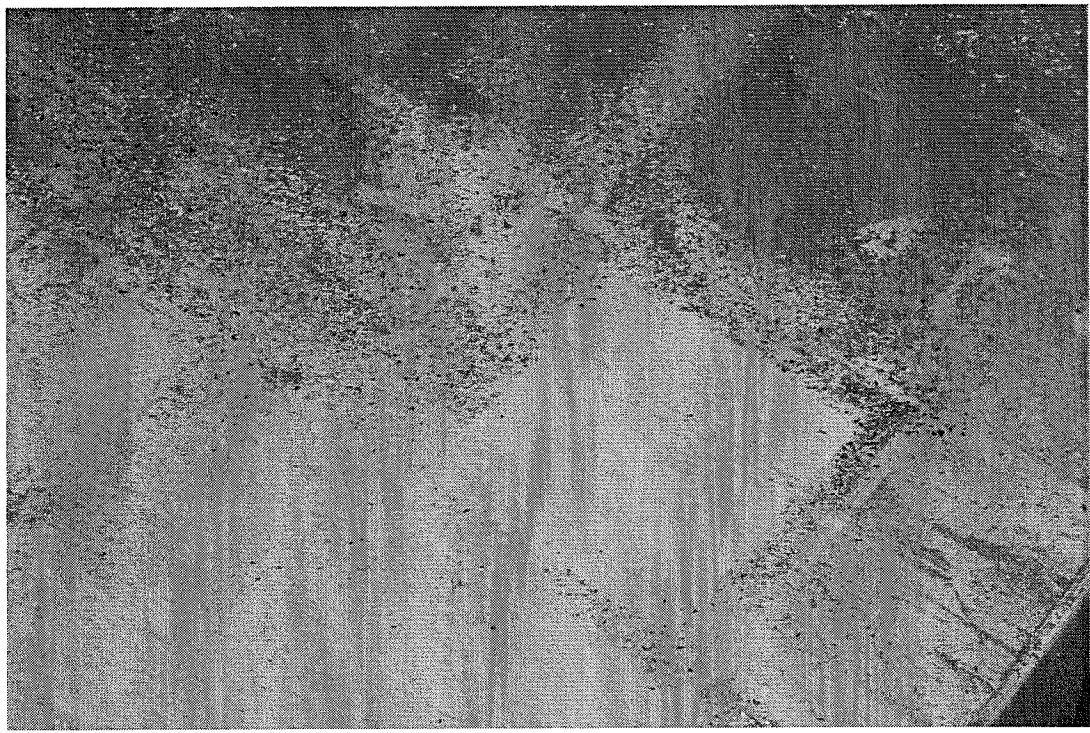
Photo 88. Main Terminal, Basement, Mechanical Rm - Location of dust samples #3 and #4 (top of wood storage shelf)

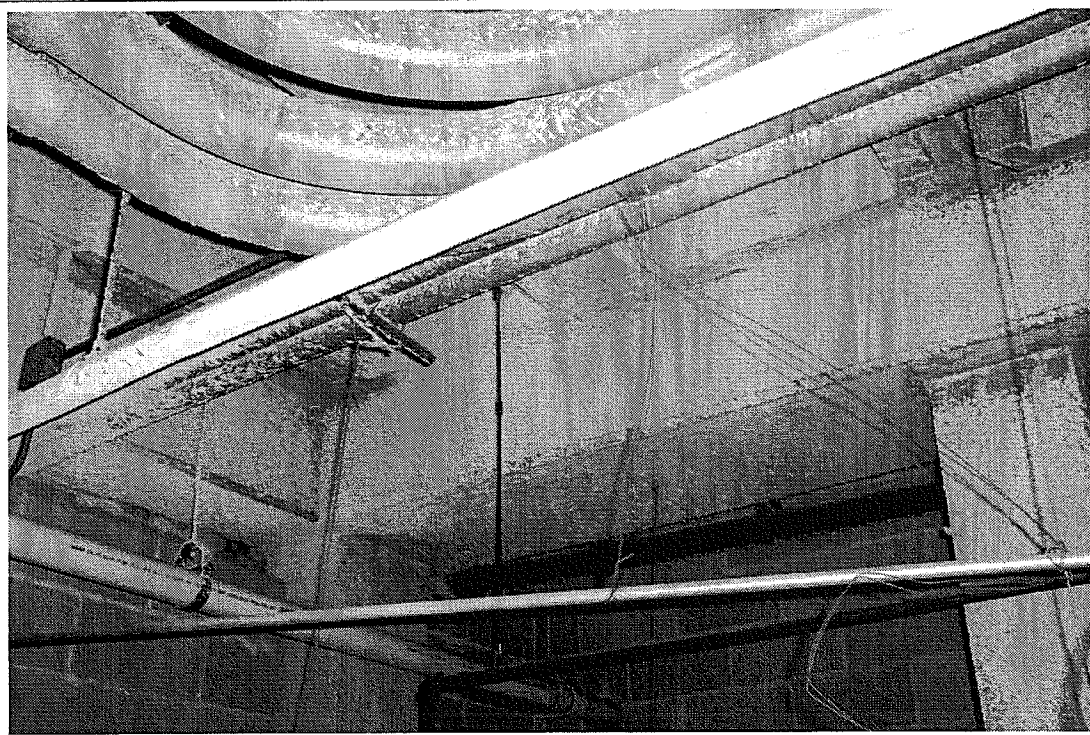
Photo 89. Main Terminal, Basement, South Hallway - General view of fireproofed concrete decking and structure above Ladies Rm

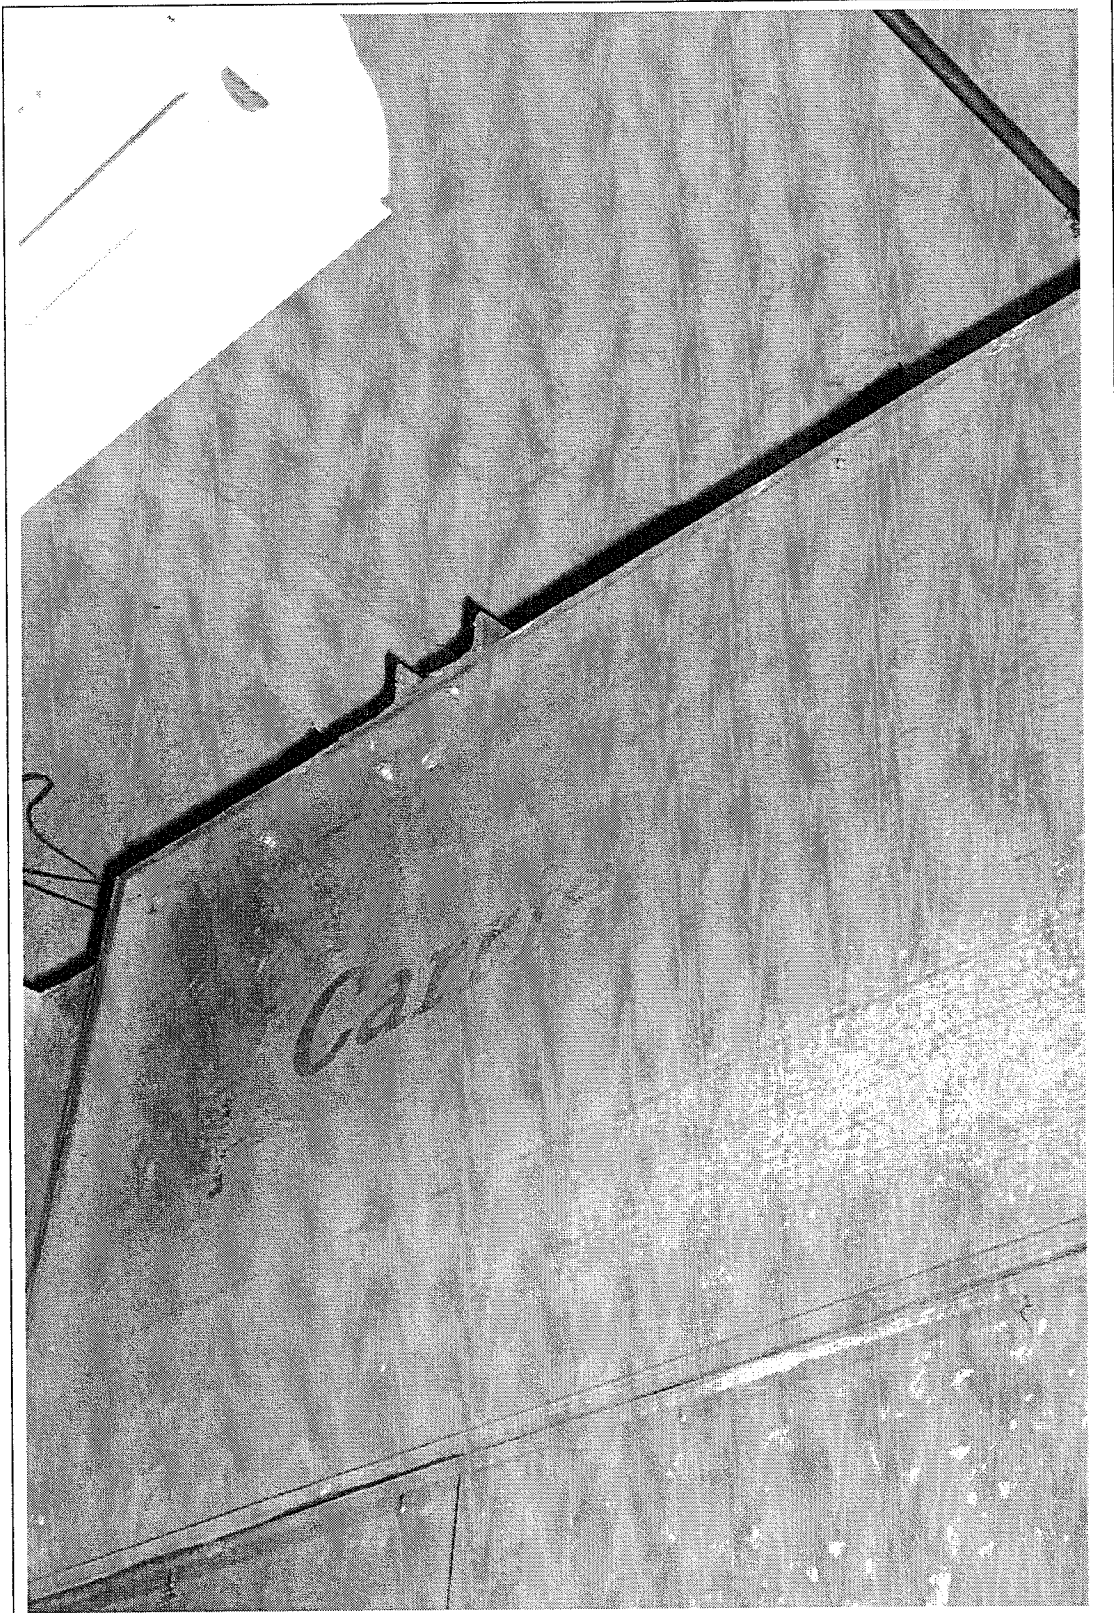
Photo 90. Main Terminal, 3rd floor, Air Handler Room - Exposed fireproofed decking above HVAC fan unit

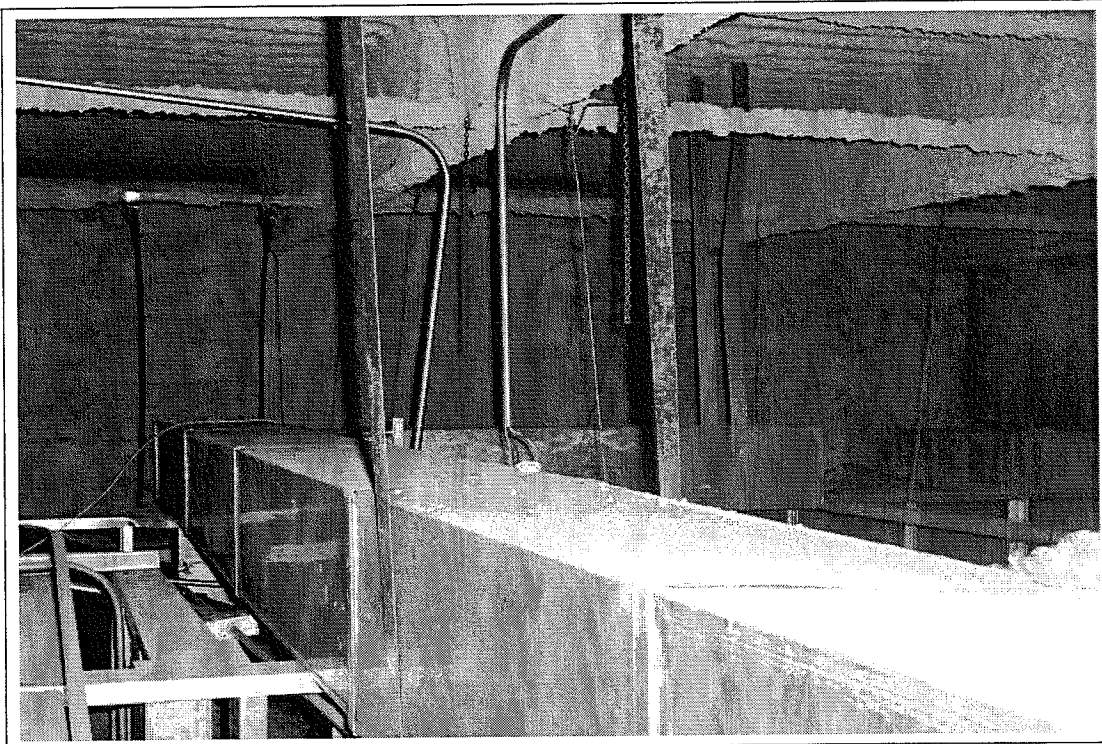
Photo 91. Main Terminal, 3rd floor, Men's Rest Room - View of delaminated fireproofing dust and debris on top of metal HVAC duct

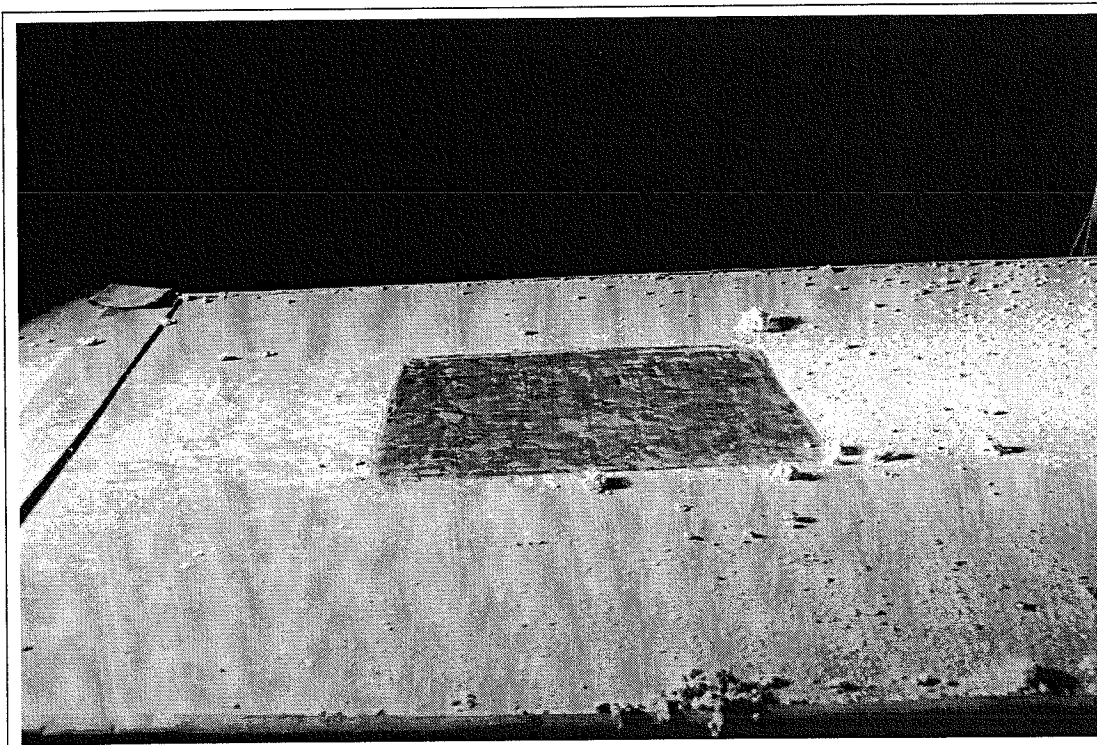
Photo 92. Main Terminal, 3rd floor, Men's Rest Room - Close-up of dust sample #6 location (top of HVAC duct)
